# Report on the Task Force on RHIC Detector Operations

On April 16, 2016 Associate Lab Director Berndt Mueller formed a task force to investigate the operational processes that were in place during the 2015 RHIC Run to ensure that the RHIC detectors were making optimal use of the resources devoted to their operation. The formation of the task force was occasioned by the recent realization that two recently installed subsystems, the PHENIX MPC-EX and STAR HFT, had major issues in their operational configurations during the entirety of RHIC Run 15, extending into the first few weeks of RHIC Run 16 in the case of the STAR HFT. The task force was charged with identifying the root causes of the failures and recommending appropriate changes and improvements in the way the readiness and performance of detector systems at RHIC are monitored before and after RHIC runs in order to avoid similar failures in the future. The task force was composed of James Dunlop (chair), Michael Begel, Mickey Chiu, Bill Christie, Leo Greiner, John Lajoie, Laurence Littenberg, David Morrison, and Zhangbu Xu.

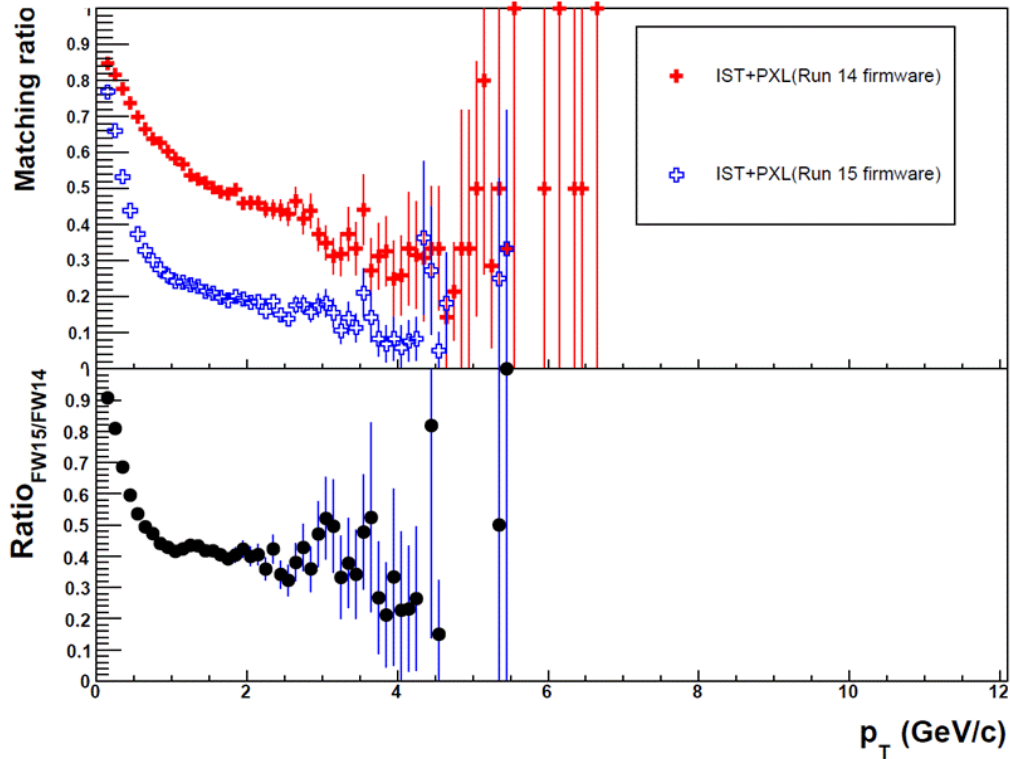
A fast analysis of STAR Run16 Au+Au data taken near the beginning of the run showed a (tracks with at least 3 HFT hits / TPC tracks) matching ratio lower than the ratio observed in the Au+Au Run14 data set. The difference was significant, more than a factor of two (see figure below). This observation triggered a series of checks on the PXL detector configuration and data processing chain. By switching between different PXL firmware versions and taking data during the early part of the current RHIC Run in similar conditions of luminosity and trigger rate, it was found that the data taken with the firmware used during Run15 and in the first 3 weeks of Run16 (revision r865) displays a significant drop in the tracking efficiency with respect to the data taken with the firmware used during Run14 (revision r700).

**FIGURE 1: HFT/TPC TRACK MATCHING RATIO AS A FUNCTION OF THE TRACK MOMENTUM. ALL PLOTS MADE WITH RUN 16 DATA. THE RED SOLID CROSSES REFER TO THE DATA TAKEN WITH THE FIRMWARE USED IN RUN 14 (r700), BLUE OPEN CROSSES TO THE RUN 15 FIRMWARE (r865). THE RUN 15 FIRMWARE MATCHING EFFICIENCY NORMALIZED TO THE RUN 14 FIRMWARE EFFICIENCY IS SHOWN IN THE BOTTOM PANEL.**

When spotted, as remediation to the observed effect, STAR immediately rolled back to Run14 firmware (r700) for the rest of Run16 data taking. At our current state of knowledge, this is the most efficient and safest PXL configuration and allows for a track matching efficiency as large as the one observed in Run14. Recent simulations reproduce the current PXL performance within 5%.

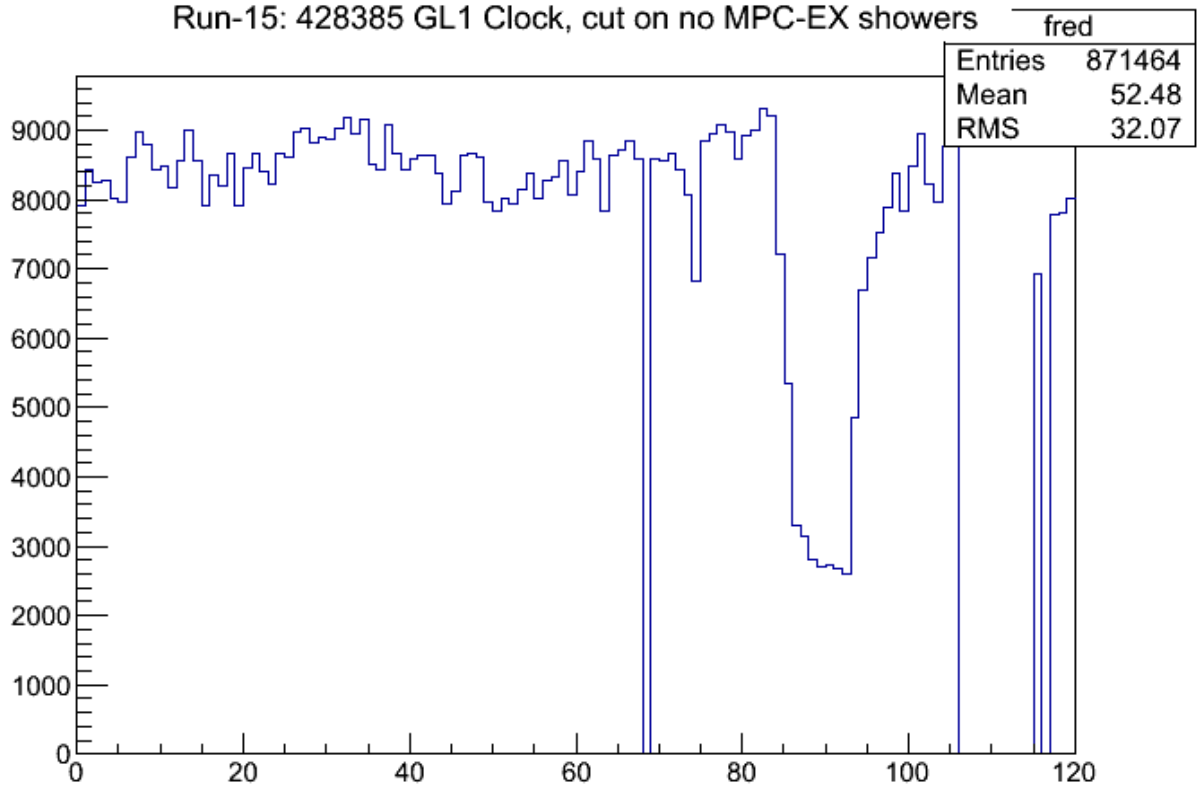
Figure 2 shows the distribution of events with at least one MPC-EX shower found by the offline reconstruction software as a function of the GL1 crossing number. The mistiming of the detector can be seen as a "reflection" of the abort gap in this distribution, approximately 20BCLKs earlier than the true abort gap.

**FIGURE 2: THIS IS THE NUMBER OF EVENTS WITH AT LEAST ONE MPC-EX SHOWER AS A FUNCTION OF THE GL1 CROSSING NUMBER. THE ABORT GAP IS CLEARLY VISIBLE STARTING AT CROSSING 107. THIS REGION IS DEPOPULATED BECAUSE THERE ARE NO TRIGGERS IN THIS REGION. THE REDUCTION OF SHOWERS ROUGHLY 20 BCLKS EARLIER IS THE REFLECTION OF THE ABORT GAP AS SEEN BY THE MPC-EX TIMING, AND THE REDUCTION OF SHOWERS IS DUE TO THE LACK OF COLLISIONS IN THE ABORT GAP. THIS IS STRONG EVIDENCE FOR THE MISTIMING OF THE MPC-EX.**

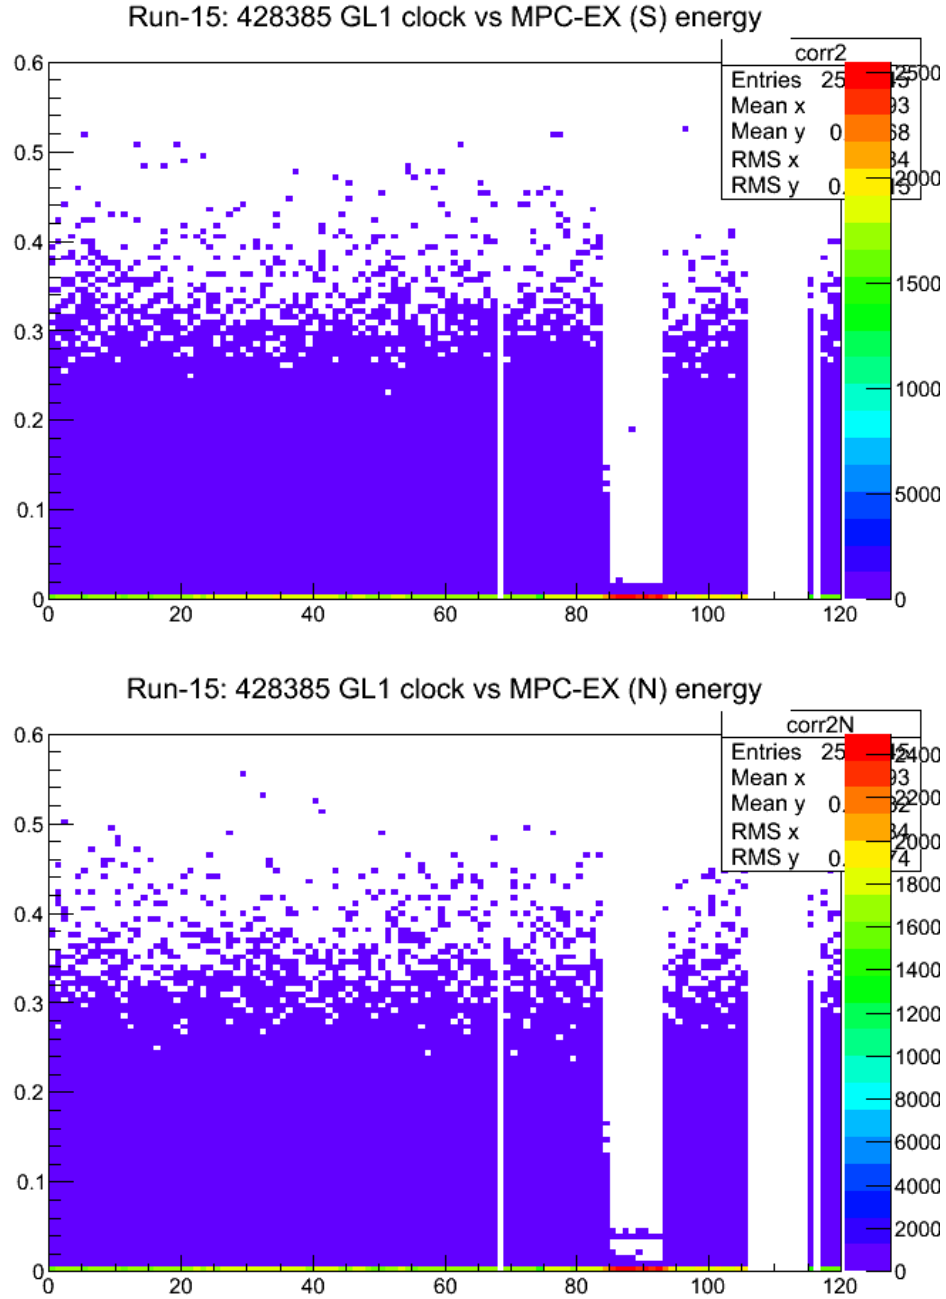
Figure 3 shows the MPC-EX minipad energy distribution (vertical axis, in arbitrary units) as a function of the GL1 crossing number. This is a less "processed" value than the number of showers found by the reconstruction software, and it clearly shows a depletion on the energy distribution in a region 20BCLKs prior to the abort gap, indicating the loss of showers in Figure 1 is not an issue with the shower reconstruction software but is seen in the energy measured in the detector.

**FIGURE 3: THIS FIGURE SHOWS THE MPC-EX MINIPAD ENERGY DISTRIBUTION (VERTICAL AXIS, IN ARBITRARY UNITS) AS A FUNCTION OF THE GL1 CROSSING NUMBER. THIS IS A LESS “PROCESSED” VALUE THAN THE NUMBER OF SHOWERS FOUND BY THE RECONSTRUCTION SOFTWARE, AND IT CLEARLY SHOWS A DEPLETION ON THE ENERGY DISTRIBUTION IN A REGION 20BCLKS PRIOR TO THE ABORT GAP, INDICATING THE LOSS OF SHOWERS IN FIGURE 1 IS NOT AN ISSUE WITH THE SHOWER RECONSTRUCTION SOFTWARE BUT IS SEEN IN THE ENERGY MEASURED IN THE DETECTOR.**

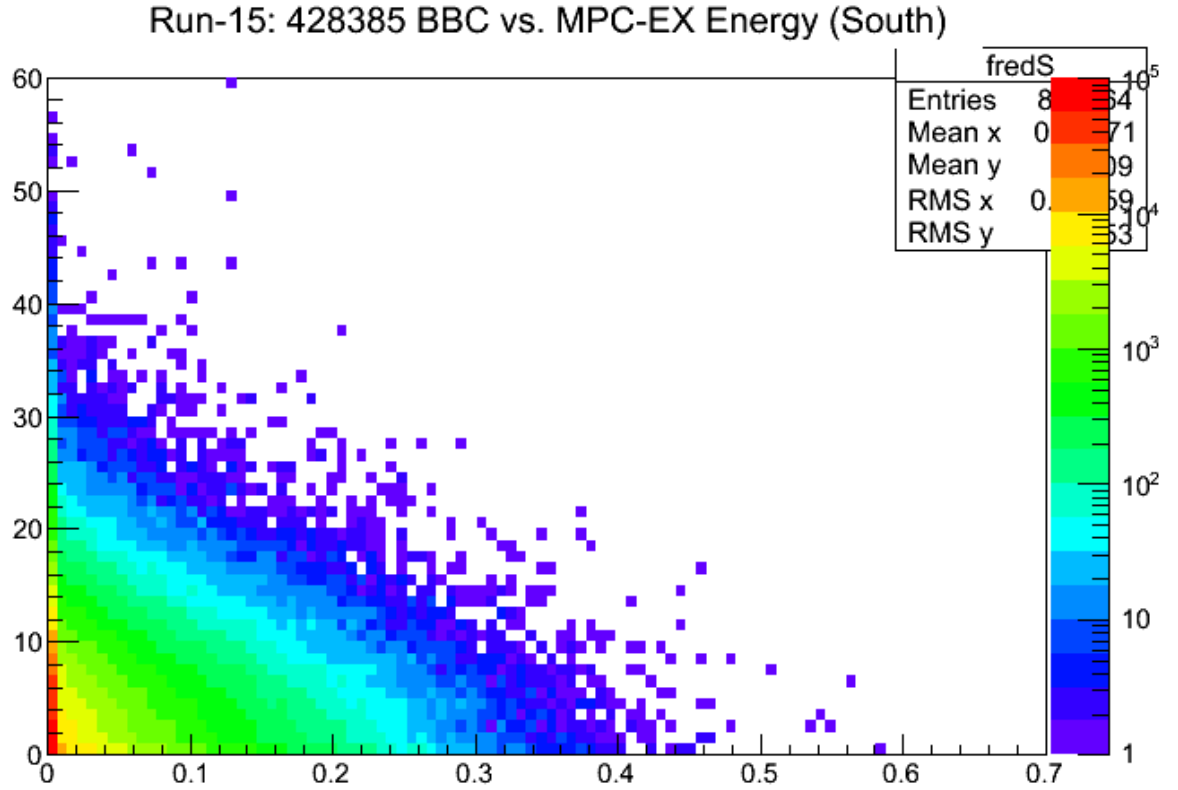
In order to examine the correlation with the BBC the fully calibrated MPC-EX energy sum is compared with the BBC charge for the south arm of the PHENIX detector (Figure 4). The MPC-EX calibrations include the elimination of hot channels and hits from SVX4 chips with CellID problems. This correlation, based on calibrated data, shows that the BBC and MPC-EX are not correlated – they are not looking at the same beam crossing. Note, however, the extent of the correlation in p+p, as compared to Au+Au (see Figure 6).

**FIGURE 4: THIS FIGURE SHOWS THE CORRELATION BETWEEN THE BBC CHARGE (VERTICAL AXIS) VERSUS THE MPC-EX SUMMED MINIPAD ENERGY (HORIZONTAL AXIS) FOR THE SOUTH ARM. THIS PLOT IS A RESULT OF THE NEW OFFLINE FRAMEWORK WITH FULL CALIBRATIONS, AND HOT AND DEAD CHANNELS REMOVED.**

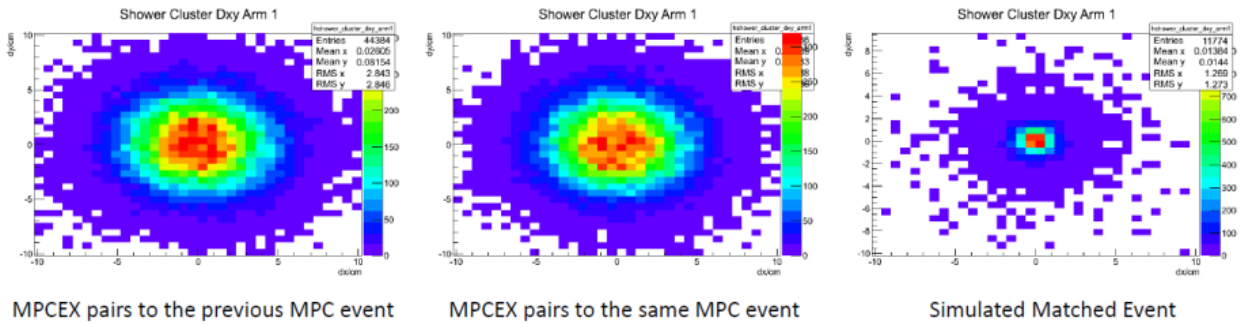
In Figure 5 we show a spatial correlation between MPC-EX showers and MPC clusters in real data and in simulations. As with the BBC correlations, these results support the idea that the MPC-EX is mistimed with respect to the MPC as the correlations are consistent with random association.

**FIGURE 5: A COMPARISON OF THE SPATIAL MATCHING IN X (HORIZONTAL) AND Y (VERTICAL) BETWEEN AN MPC-EX SHOWER AND A CLUSTER IN THE MPC. THE CENTER PANEL SHOWS MATCHING IN RUN-15 DATA IN THE SAME EVENT, THE LEFTMOST PANEL SHOWS MATCHING TO THE PREVIOUS EVENT (DELIBERATELY MISTIMED) AND THE RIGHTMOST PANEL SHOWS THE EXPECTATION IN SIMULATIONS, INCLUDING THE MPC-EX DEAD AREAS IN RUN-15. THE CONCLUSION IS THAT IN RUN-15 DATA THE MATCHING IS CONSISTENT WITH RANDOM ASSOCIATION.**

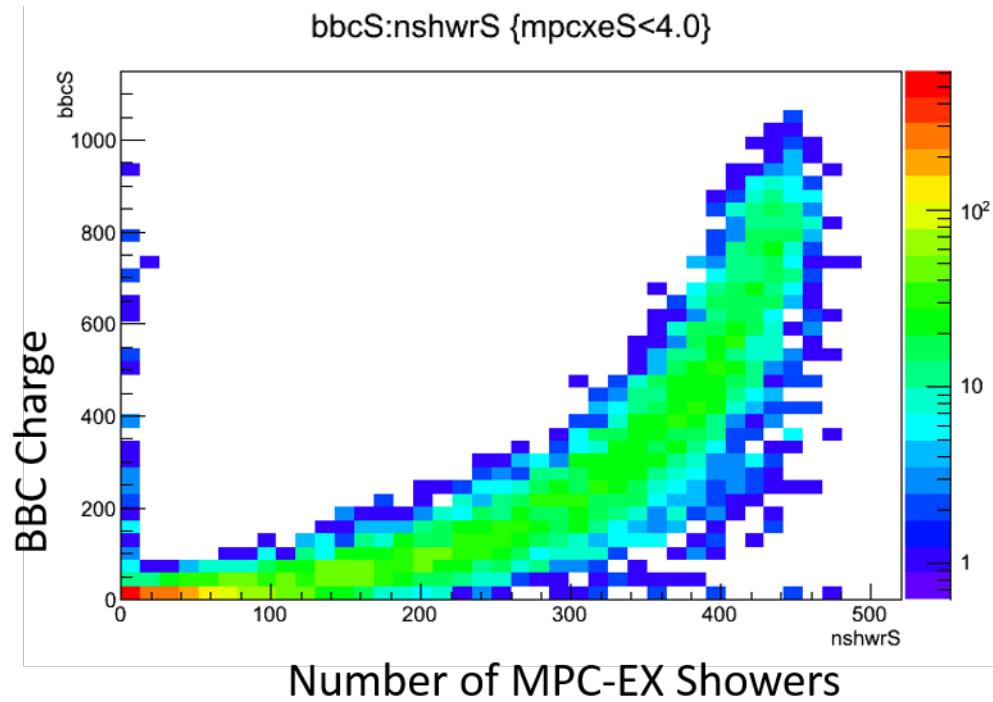
**FIGURE 6: CORRELATION OF THE BBC CHARGE WITH THE NUMBER OF SHOWERS FOUND IN THE MPC-EX FOR THE PHENIX SOUTH ARM IN RUN-16. THE LEVEL-1 DELAY FOR THE SOUTH MPC-EX HAS BEEN CORRECTED AND TIMED-IN RELATIVE TO THE BBC, PRODUCING A CLEAR CORRELATION BETWEEN THE NUMBER OF SHOWERS AND THE BBC CHARGE.**

Figure 6 shows the correlation between the BBC charge and the number of MPC-EX showers in Run-16 Au+Au data. This correlation changes dramatically with a variation of the Level-1 delay of  $\pm 1$ BCLK, clearly indicating the correct beam crossing, as shown in Figure 7.

In addition to the investigations of the Run-15 data, the detector timing exercise in Run-16 Au+Au collisions was completed for both the north and south MPC-EX. The SVX4 serial download was corrected, and following the original plan from Run-15 a Level-1 delay scan was performed around the nominal value of 40BCLKs, as expected from the VTX strip pixels. Due to the higher multiplicity in Au+Au collisions, and the improved detector performance, it was not necessary to look at MIPs in the MPC-EX but the MPC-EX summed energy (or number of showers) could be compared directly to the BBC charge. The appropriate Level-1 delays for the north and the south were quickly identified.

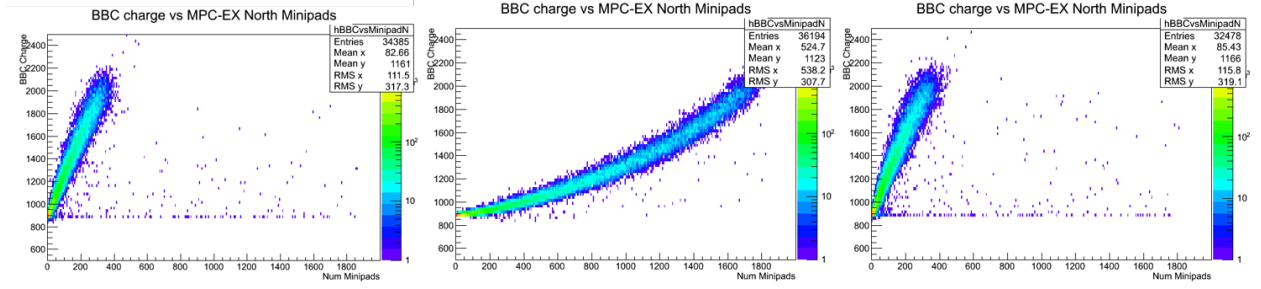
**FIGURE 7: CORRELATIONS BETWEEN THE BBC CHARGE AND NUMBER OF HIT MINIPADS IN RUN-16 AU+AU DATA. THE CENTRAL PANEL SHOWS THE CORRELATIONS WITH THE LEVEL-1 DELAY ADJUSTED SO THE BBC AND MPC-EX ARE ON THE SAME BEAM CLOCK, WHILE THE LEFT AND RIGHT PANELS SHOW THE EFFECT OF SHIFTING THE LEVEL-1 DELAY AWAY FROM THE CORRECT VALUE.**

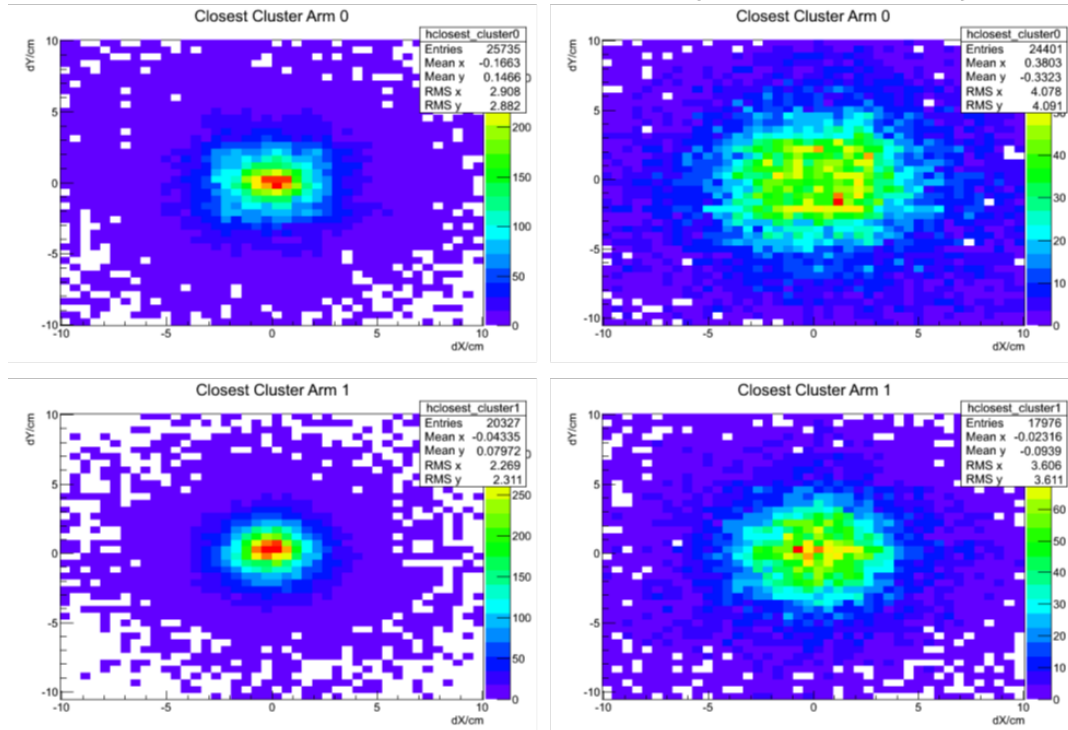
**FIGURE 8: A COMPARISON OF THE SPATIAL MATCHING IN X (HORIZONTAL) AND Y (VERTICAL) BETWEEN AN MPC-EX SHOWER AND A CLUSTER IN THE MPC IN RUN-16 DATA. THE COMPARISON IS MADE FOR MPC CLUSTERS WITH AN ENERGY > 1.5 GeV, AND FOR MPC-EX SHOWERS WITH ENERGY IN SEVEN OR MORE LAYERS OF THE MPC-EX. THE LEFT HAND COLUMN SHOWS THE MATCHING IN LOW-MULTIPLICITY Au+Au events (BBC CHARGE < 200) IN THE NORTH ARM (TOP) AND SOUTH ARM (BOTTOM). THE SAME COMPARISON IS SHOWN FOR MIXED EVENTS WHERE THE MPC-EX SHOWER AND MPC CLUSTER ARE DRAWN FROM DIFFERENT EVENTS. THE SAME-EVENT COMPARISON IS SIMILAR TO THAT EXPECTED FROM SIMULATIONS AS SHOWN IN FIGURE 5.**

Finally, Figure 8 shows the spatial matching between the MPC-EX shower axis in Run-16 low-multiplicity Au+Au data for both same-event and mixed event correlations. The same-event correlations compare very favorably with the correlations in simulation shown in Figure 5, and indicate that the MPC-EX shower and MPC cluster are from the same electromagnetic shower.
